Manhole Inspection Summary

Manhole # S19QQ_004MH

Insp Date: **7/10/07 9:42 AM**

Location Address: **1701 GWYNNS FALLS PKWY** Cross Street: **WOOBROOK AVE**

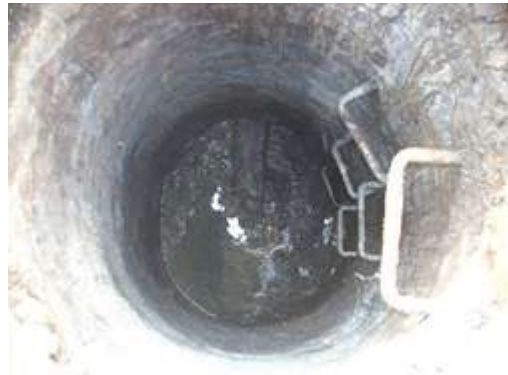
Top View

DEBRIS BLOCKING HALF OF THE CHANNEL

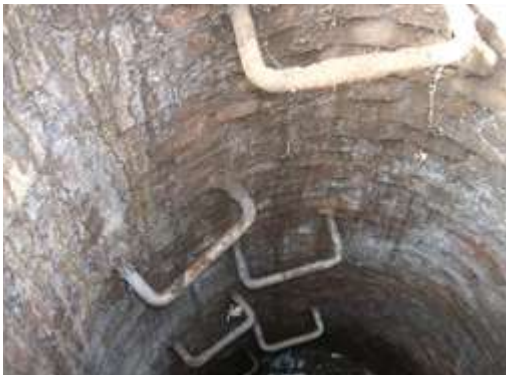
Defect 3

Corbel Material: **Brick** ☐ Parged Type: **Concentric/Eccentric**
Condition: ☒ Sound ☐ Cracked ☐ Root Intrusion ☐ Loose Brick ☐ Deteriorated
Infiltration: ☐ None ☐ Joint ☐ Cracks ☐ Mortar ☐ Roots ☒ **Wall**

Steps Count: **6** Missing: **0** ☒ **Corroded**

CORRODED STEPS AND INFILTRATION STAINING ON CORBEL

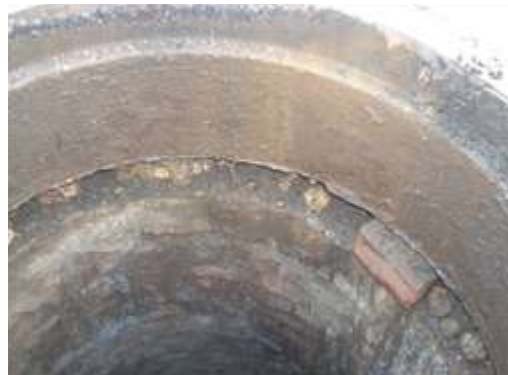
Defect 2

Chimney / Frame Adjustment ☒ Exists Material: **Brick and Stone** ☐ Parged Height: **3** (in.)
Condition: ☐ Sound ☐ Cracked ☐ Root Intrusion ☐ Loose Brick ☒ **Deteriorated**
Infiltration: ☒ None ☐ Joint ☐ Cracks ☐ Mortar ☐ Roots ☐ Wall

DETERIORATION OF CHIMNEY

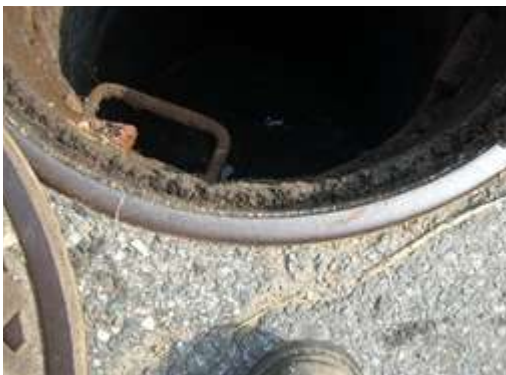
Defect 1

Frame Offset: **1** (in.) Condition: ☒ Sound ☐ Cracked ☐ Leaks

FRAME OFFSET

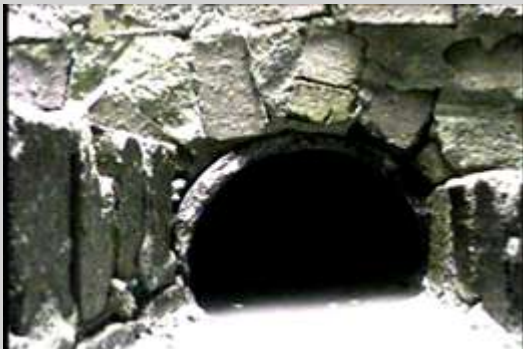
5 O'Clock Inflow

Pipe Height: **8.4** (in.) Rod and Bar (Angled)
Pipe Material: **Clay** ☐ Pipe Lined
Invert Depth: **10.82** (ft.) Flow Characteristics: **Slow**
Deposits: ☐ None ☐ Mud ☐ Sludge ☒ **Debris** ☐ Grease
Silt Depth: **7** (in.) Deposits Extent: **Heavy**
Infiltration: **None** Pipe Seal Cond: **Sound**
